SANTA BARBARA
CITY COLLEGE

Facility Master Plan

2019

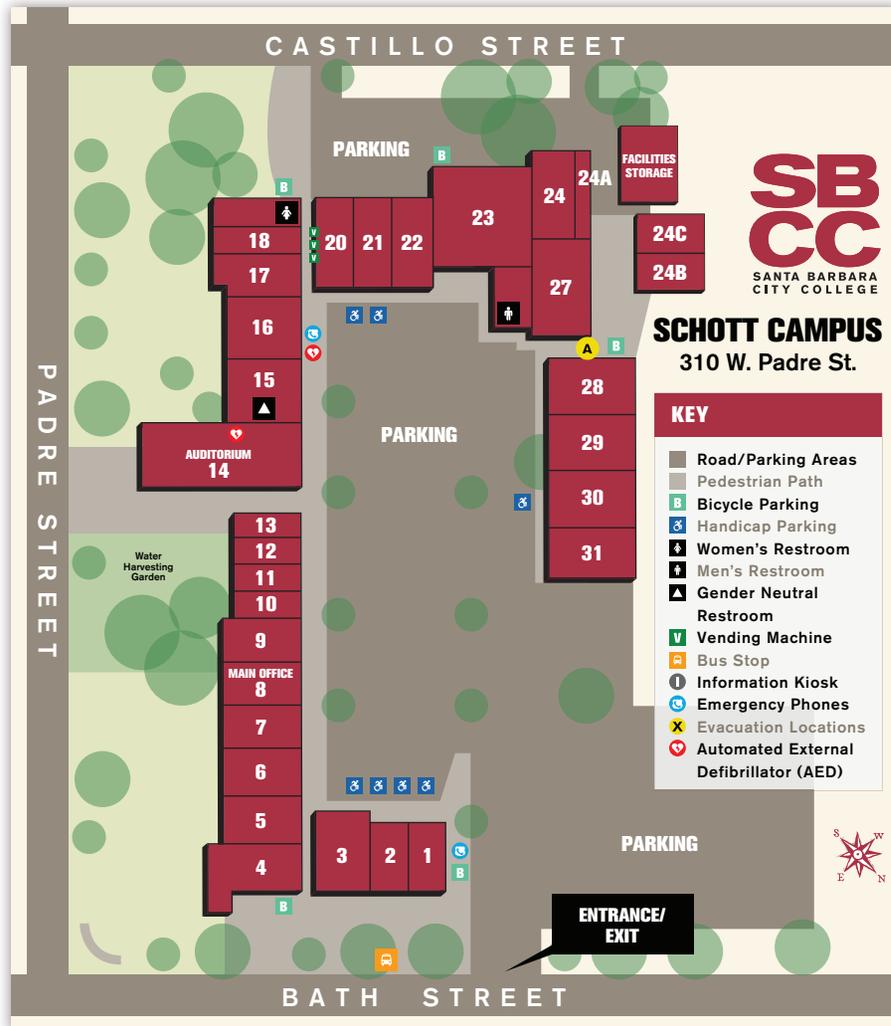
Schott Campus Map

The Schott Campus is located at 310 West Padre Street, Santa Barbara, California. The one-story 20,072 SF building, located on Padre Street, is a former elementary school originally constructed in 1935. The building was renovated in 1981, the auditorium was renovated in 2001, and the electrical system was renovated/upgraded in 2005 with no major remodels to date (2019). Modular buildings were installed in 1989 and 1996.

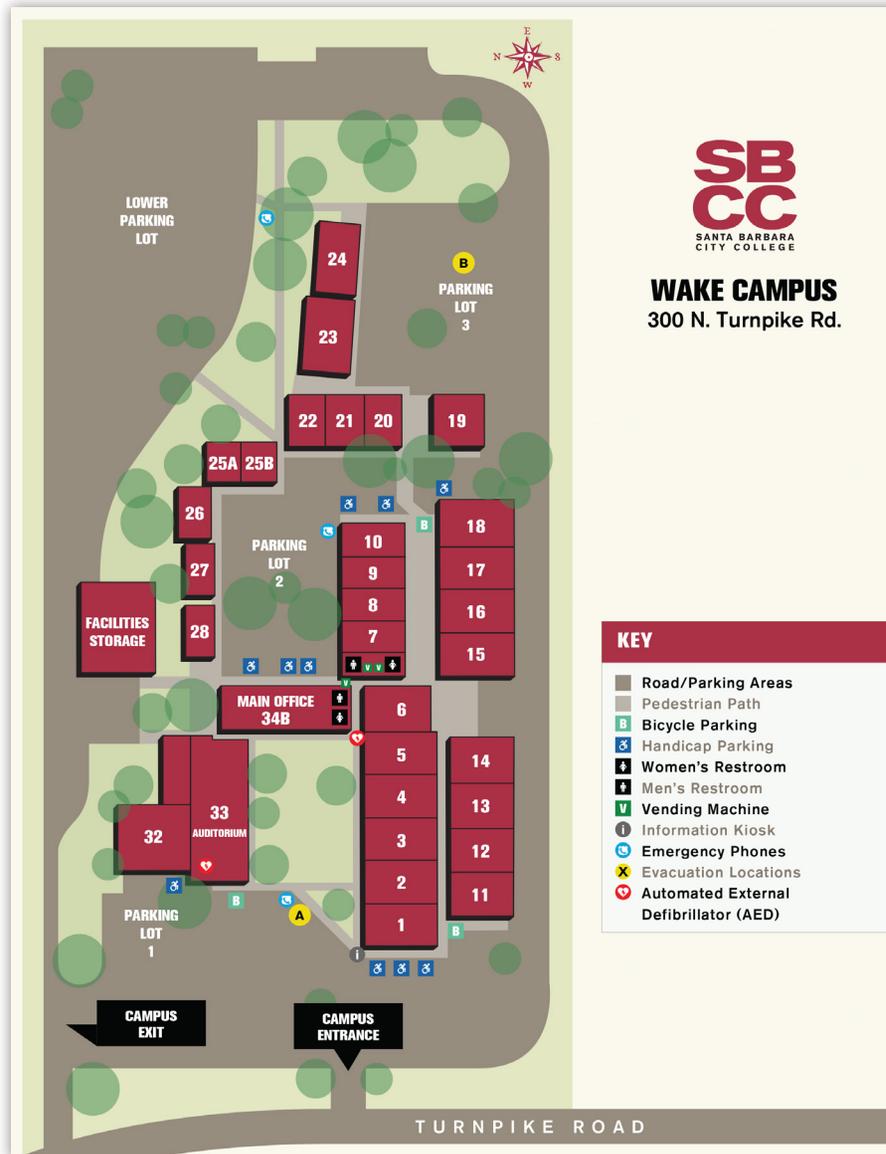
Wake Campus Map

The Wake Campus is located at 300 North Turnpike Road, Santa Barbara California. The one-story 53,968 SF building, located on Turnpike Road, is a former elementary school originally constructed in 1956. There have been no major renovations or remodels to date (2019). Modular buildings were installed in 1970, 1988, 1991, 2007, and 2010.
